USAAEFA PROJECT NO. 84-14

PRELIMINARY AIRWORTHINESS EVALUATION OF THE UH - 1H HIND-D SURROGATE

JANUARY 1985

FINAL REPORT

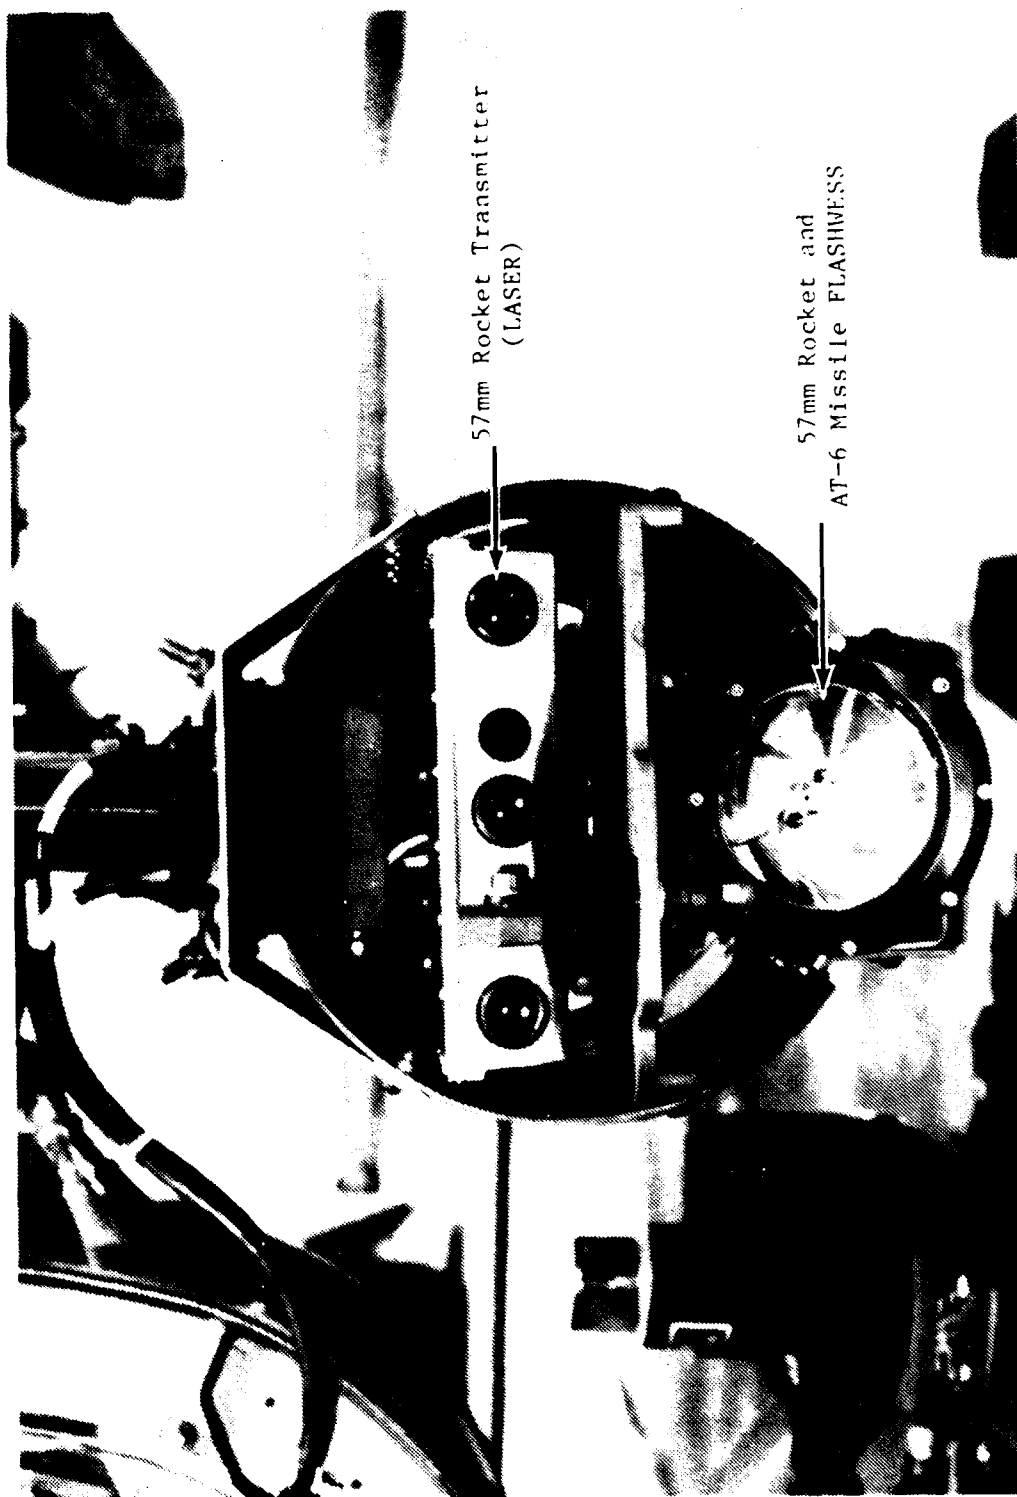
Photo 8. Launcher Pod - Left Wing Store

d. Launcher pod which includes a FLASHWESS and the 57mm Rocket transmitter (LASER) mounted on the left side.

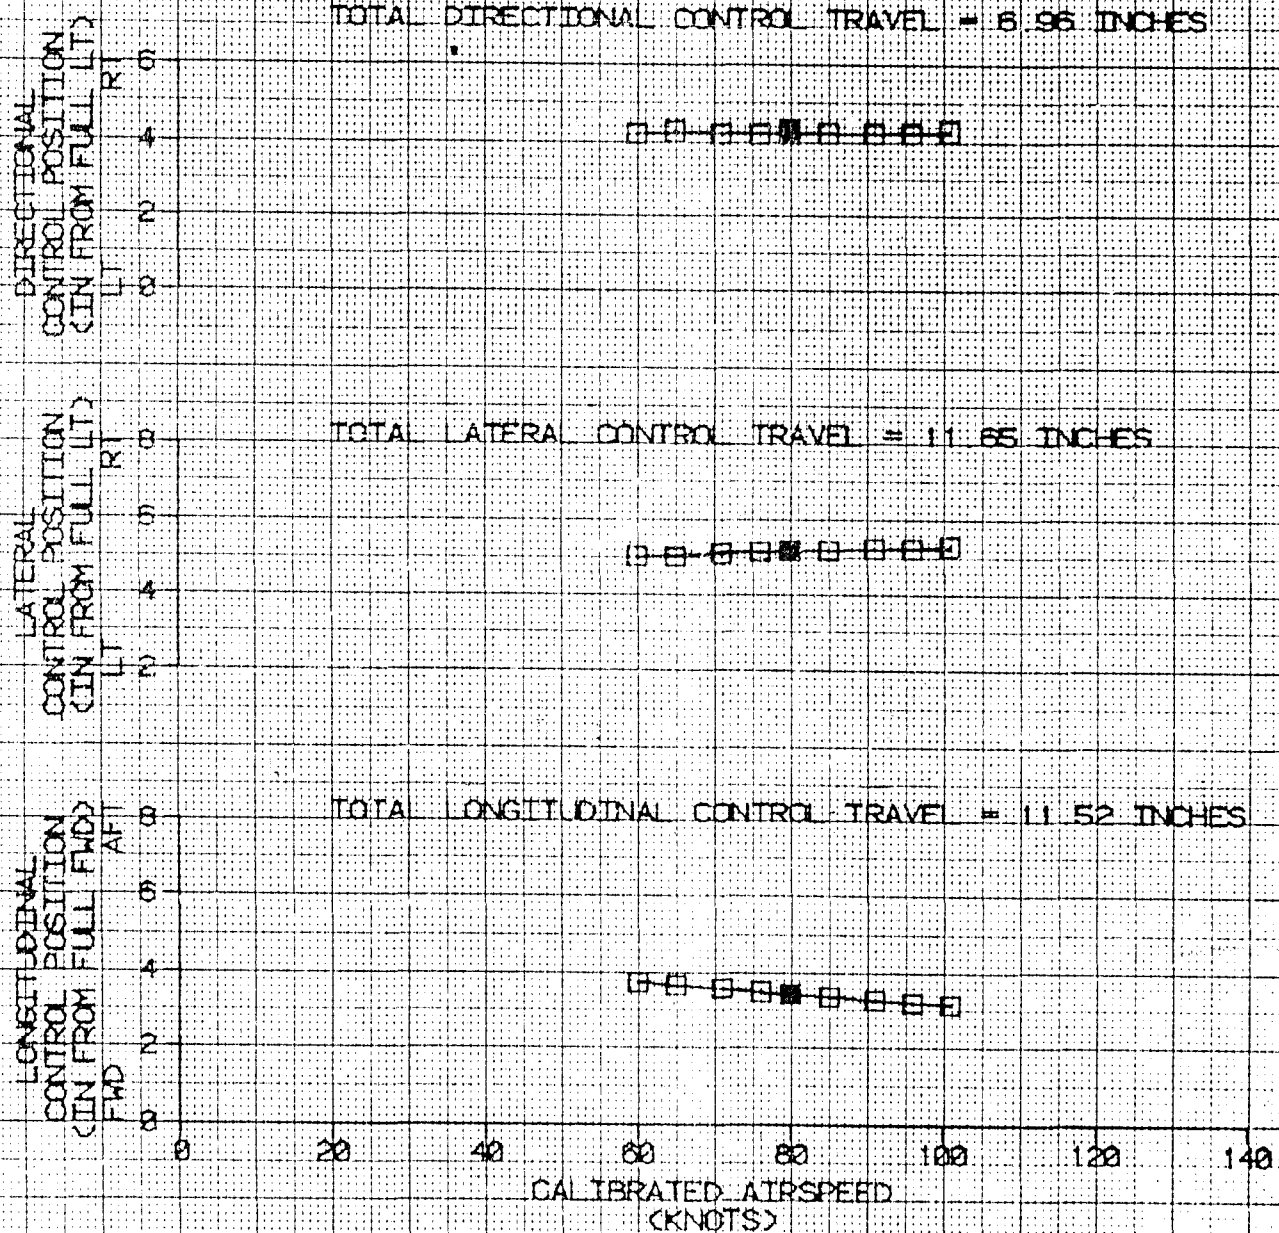
FIGURE 4

positive static longitudinal stability characteristics as indicated by increasing forward longitudinal control with increasing airspeed about trim for all conditions tested. The static longitudinal stability characteristics of the UH-1H/HIND-D Surrogate are essentially the same as a standard UH-1H helicopter.

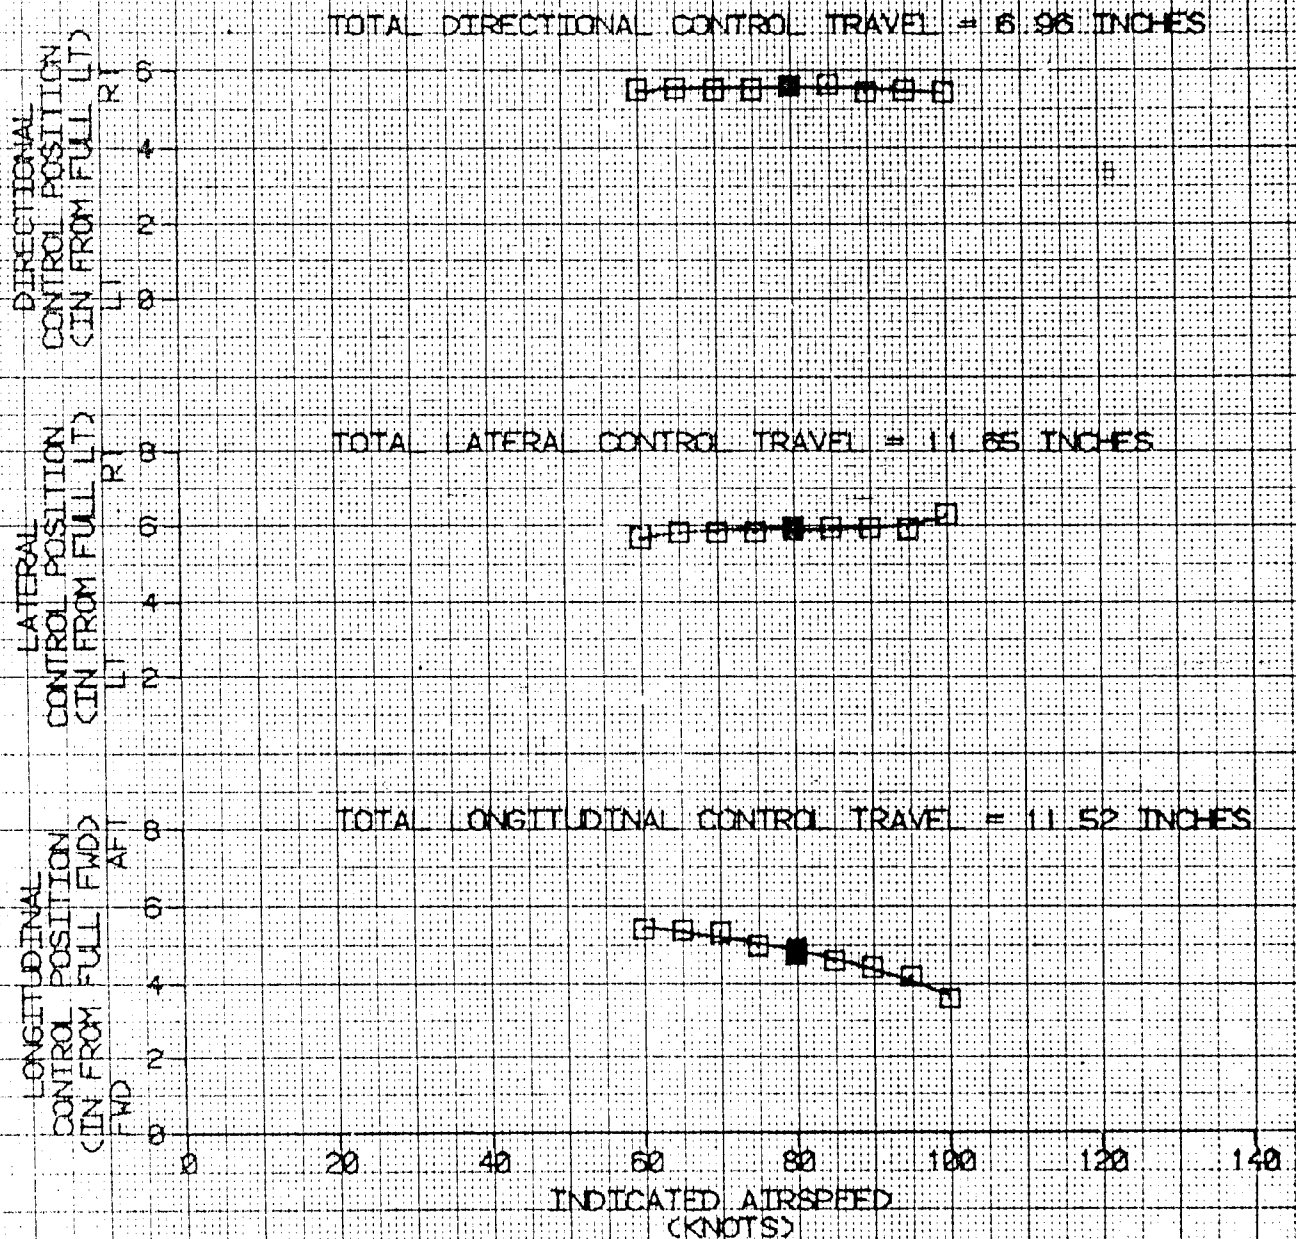
FIGURE 8
 STATIC LATERAL-DIRECTIONAL STABILITY
 UH-1H/HIND SURROGATE USA S/N 65-58928

12. Static lateral-directional stability characteristics were evaluated in level flight, MRP climbs, and autorotation. The collective control was held fixed, and sideslip angle was varied by applying directional control (left and right) to move the trim ball to half, three quarters and one ball width from center while maintaining constant airspeed and heading. Data are presented in figures 8 through 16, appendix C. At all conditions tested, the aircraft exhibited positive directional stability characteristics as indicated by increased left directional control with increased right sideslip. Positive dihedral effect as indicated by increased right lateral control with increased right sideslip was also exhibited at all conditions in level flight and autorotation. In climb, the dihedral effect was slightly positive to neutral. The static lateral-directional stability characteristics of the UH-1H/HIND-D Surrogate are essentially the same as a standard UH-1H helicopter.

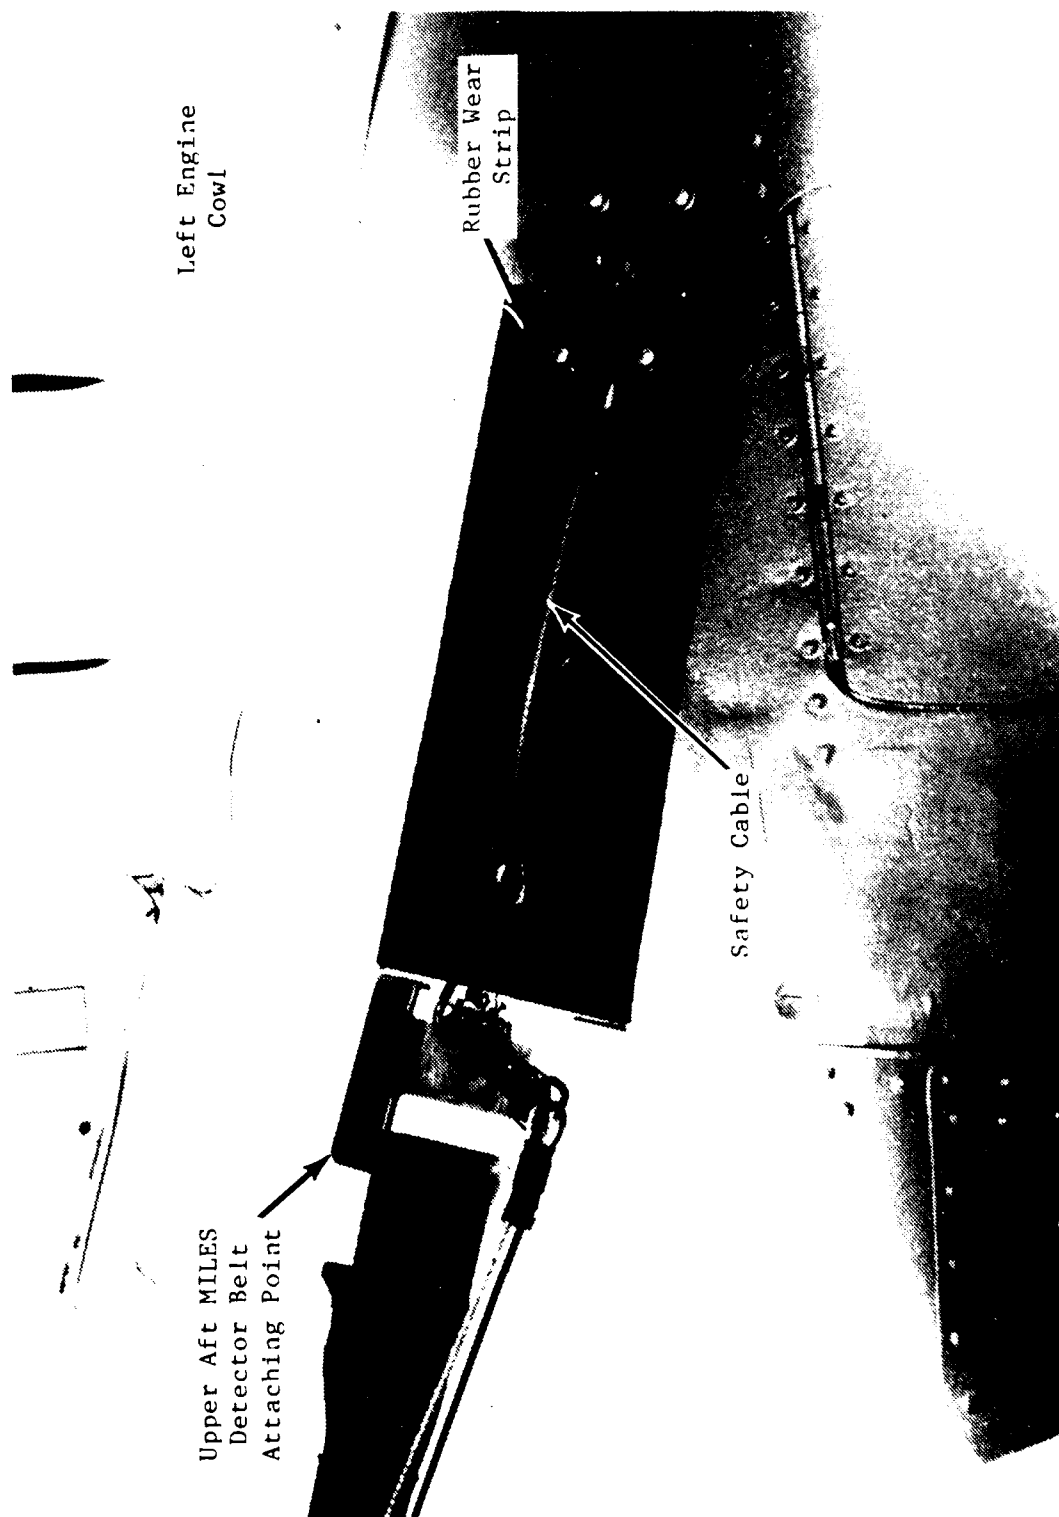
Photo 6. UH-1H/HIND-D Surrogate - Upper Aft Left Fuselage

26. A rubber wear strip attached to the left engine cowl at the upper aft MILES detector belt attaching point (photo 6, app D) debonded and separated from the aircraft during one flight. Post flight inspection revealed that an identical rubber wear strip on the right engine cowl was beginning to debond. The debonding of the rubber wear strips attached to the engine cowl at the upper aft MILES detector belt attaching points is a shortcoming. A different bonding material and/or a different type of wear strip should be used at the upper aft MILES detector belt attachment points.

b. The debonding of the rubber wear strips attached to the engine cowl at the upper aft MILES detector belt attaching points (para 26).

h. A different bonding material and/or a different type of wear strip should be used at the upper aft MILES detector belt attachment points (para 26).
